A-PRO HOME INSPECTIONS
8 SAGGESE LANE
NESCONSET, NY 11767
PREPARED BY:BLAISE INGRISANO
NYS Lic#16000035230

123 Main Street
Happy Town, NY 10000

Repair/Replace Summary

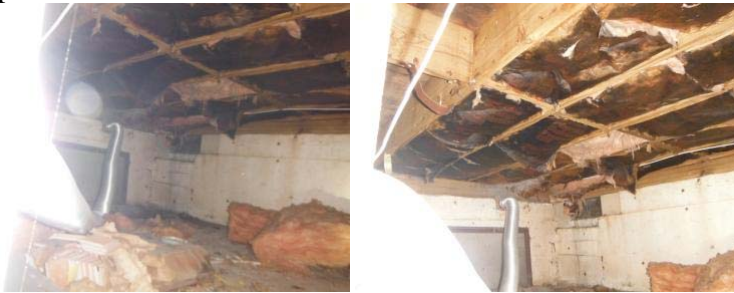
- 1. Crawl Space Insulation:** Fiberglass- Loose or damaged insulation in the floor above the crawl space should be improved.

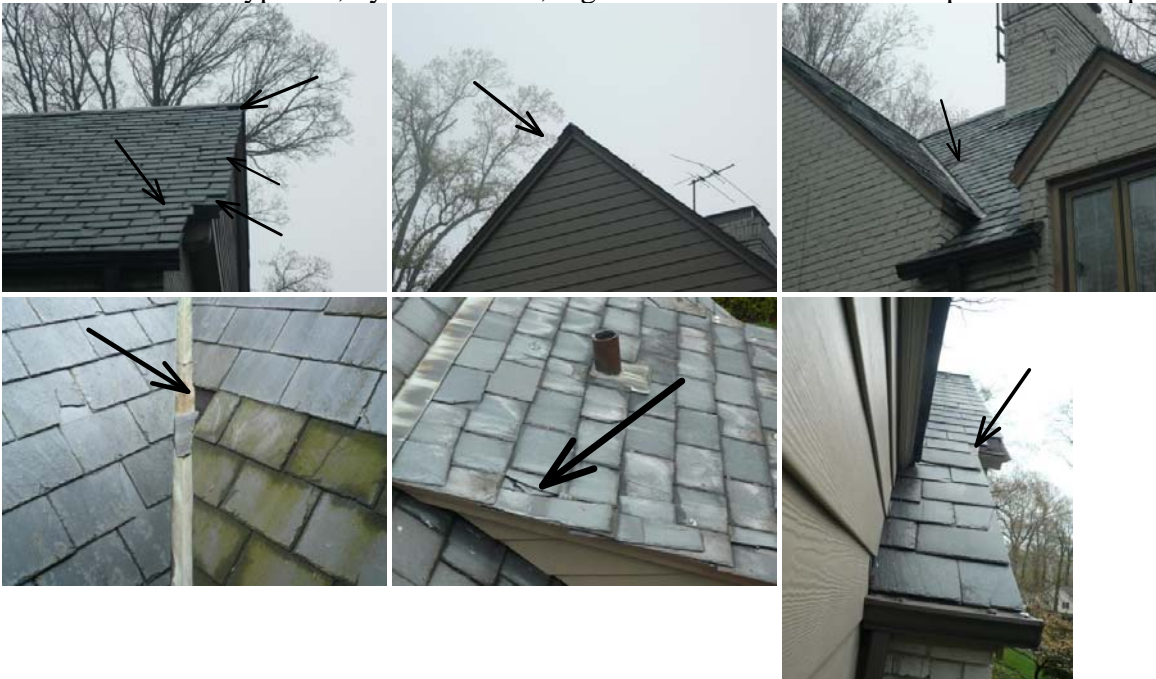
- 2. Entire roof Roof Surface Material:** Slate, Asphalt shingle- Damaged shingles should be repaired or replaced. This can lead to interior water damage if not corrected. A qualified roofing contractor is recommended to evaluate the entire roof and estimate repairs.

Slate roofs of this type are, by their nature, high maintenance. Annual inspection and repair should be anticipated.

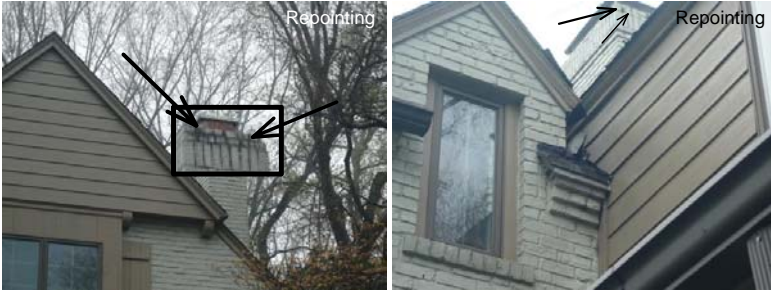
- 3. North Chimney Chimney:** Brick- The masonry chimney is in need of re-pointing (replacing the mortar between the bricks)

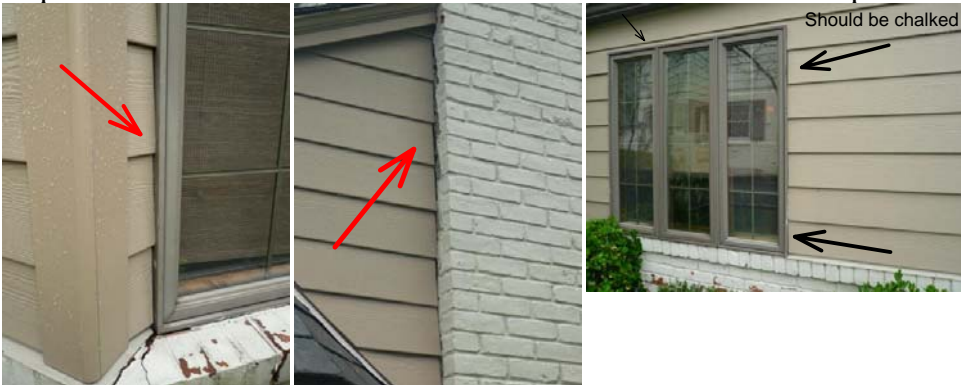
4. **Entire home Exterior Surface Type:** Hardie Plank, Brick veneer- The siding should be properly sealed where different materials meet. Any gaps between siding materials should be caulked and sealed. A qualified contractor is recommended to evaluate and estimate repairs

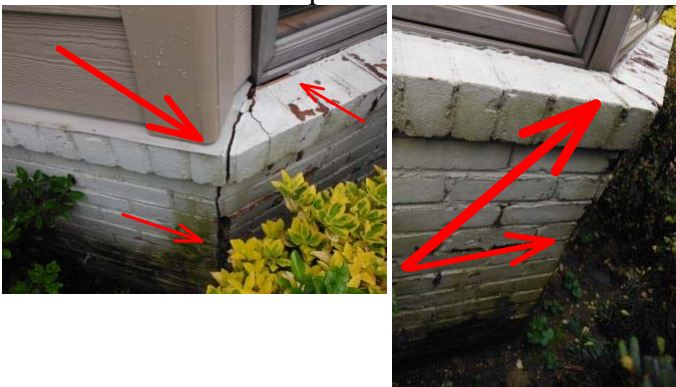
5. **Front of Home Exterior Surface Type:** Brick veneer- Damaged brickwork at the front of the home under the bay window is in need of correction, evident by brick movement, cracking, water infiltration, and windows not operating. The condition that caused this damage should be remedied and bricks repaired or replaced. Any underlying damage uncovered should also be repaired or replaced. A qualified contractor is recommended to evaluate and estimate repairs

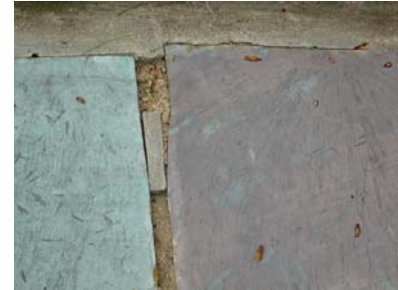
6. **Steps/Stoops:** Stone- The stair treads are loose. This is a safety concern that should be addressed promptly.

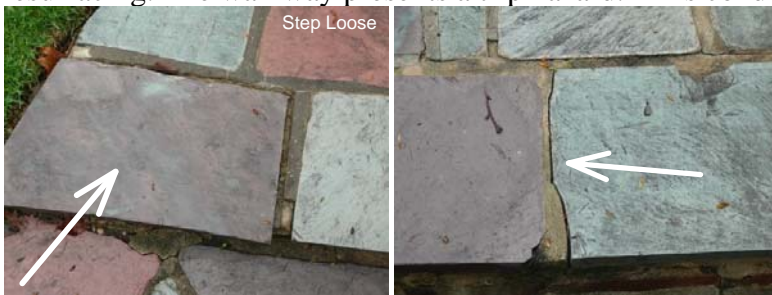
7. **Walks:** Stone- The walkway has settled and/or cracked. Persisting movement may result in the need for resurfacing. The walkway presents a trip hazard. This condition should be altered for improved safety.

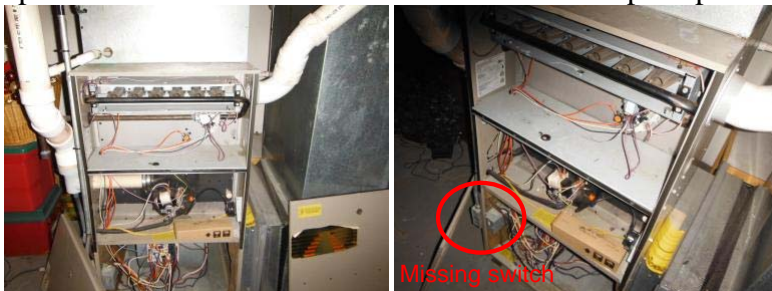
8. **Heating System Heating System Operation:** The furnace requires typical servicing by a qualified HVAC technician. to clean, service, and check the heat exchanger.

A contact switch should be installed in the lower fan compartment. This will switch will not allow the furnace to operate without the lower cover on. This will help keep the system clean and from overheating the heat exchanger.

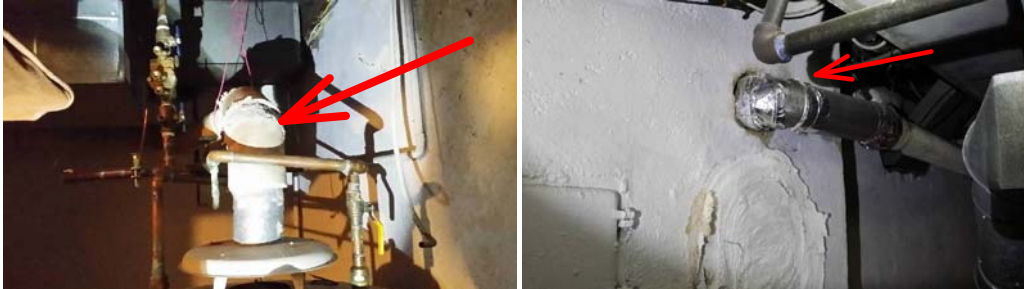
- 11. Main Water Shutoff:** Basement- Water dripping was noted at the main water valve. This condition should be corrected by a licensed plumber.
- 12. Water Heater Flue Pipe:** Metal. Cast- The flue servicing the water tank is older and may contain asbestos. In addition it does not appear to have a proper slope. It would be wise to remove this flue and upgrade. A qualified licensed HVAC technician should be consulted to evaluate and estimate repair.

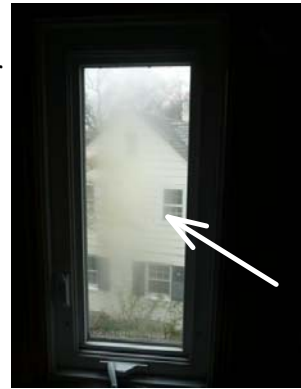
- 15. Master Bedroom Windows:** Vinyl casement- A window has lost its seal. This has resulted in condensation developing between the panes of glass. Due to weather conditions or environmental factors, other windows that have lost their seal may exist in the home. A qualified window repair contractor should be engaged to repair all windows as required

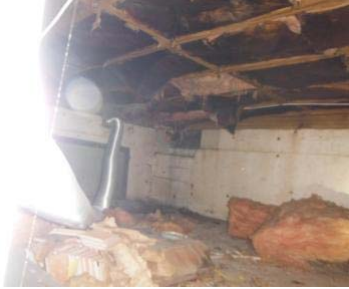
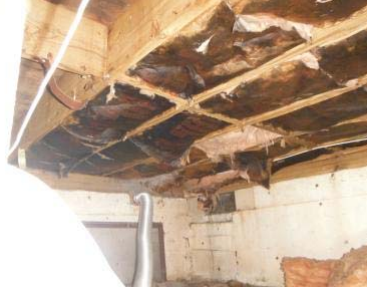
Repair/Replace **Insulation:** Fiberglass- Loose or damaged insulation in the floor above the crawl space should be improved.

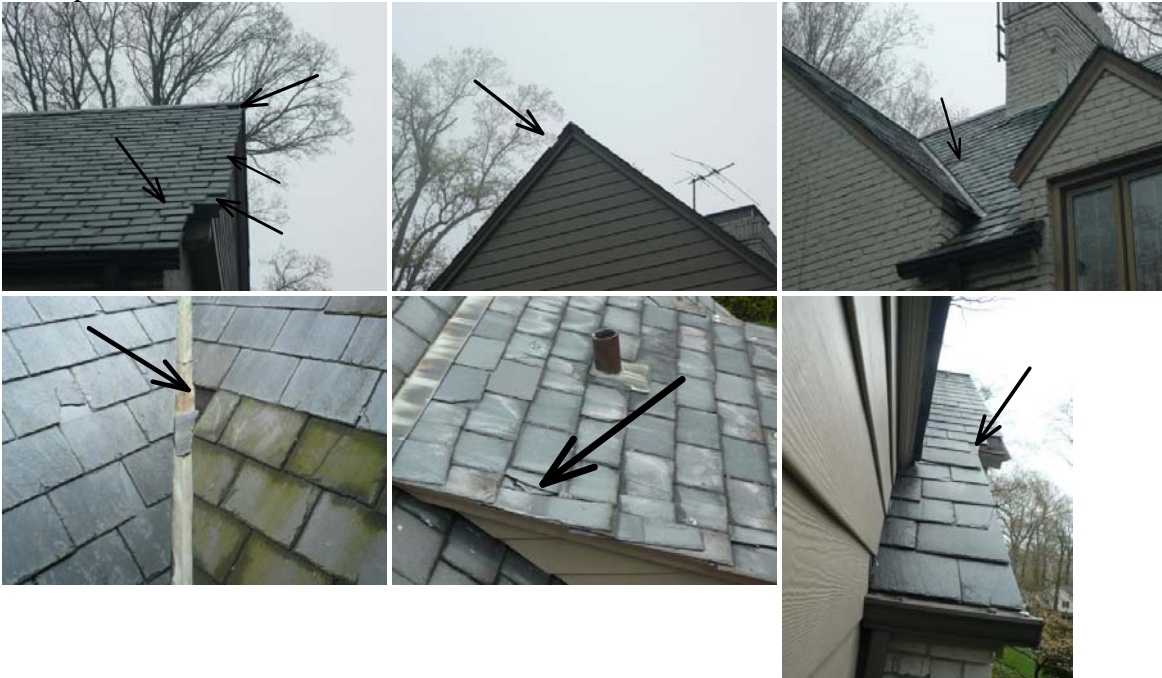
Repair/Replace Material: Slate, Asphalt shingle- Damaged shingles should be repaired or replaced. This can lead to interior water damage if not corrected. A qualified roofing contractor is recommended to evaluate the entire roof and estimate repairs.

Slate roofs of this type are, by their nature, high maintenance. Annual inspection and repair should be anticipated.

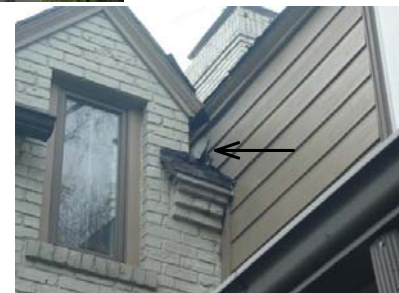
Improve **Flashing:** Copper- The flashing should be caulked.

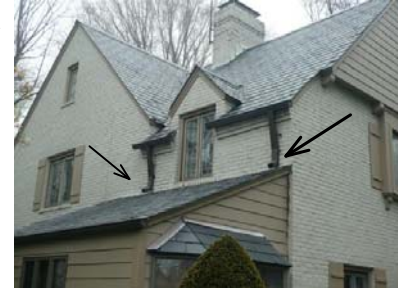
Leader/Extension: Aluminum- Downspout(s) that discharge onto the roof should be extended to discharge directly into the gutters below. This condition, if left unattended, can result in premature deterioration of the roofing adjacent to a downspout.

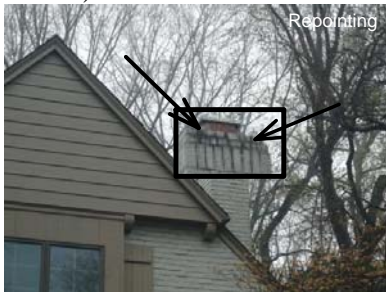
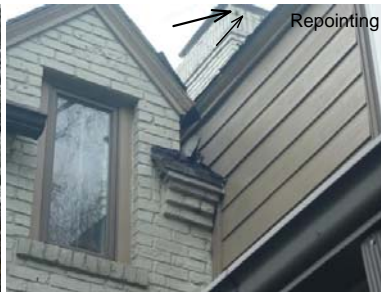
North Chimney

Repair/Replace **Chimney:** Brick- The masonry chimney is in need of re-pointing (replacing the mortar between the bricks)

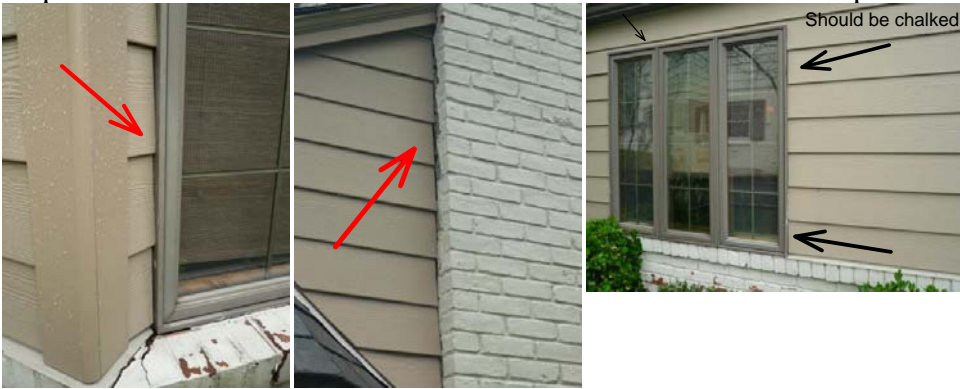
Repair/Replace **Type:** Hardie Plank, Brick veneer- The siding should be properly sealed where different materials meet. Any gaps between siding materials should be caulked and sealed.

A qualified contractor is recommended to evaluate and estimate repairs

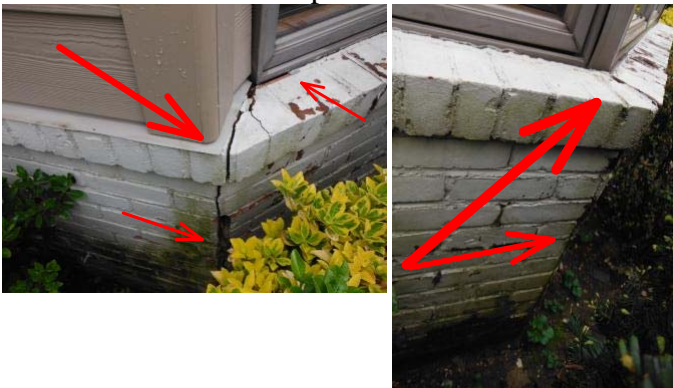
Front of Home Exterior Surface

Repair/Replace **Type:** Brick veneer- Damaged brickwork at the front of the home under the bay window is in need of correction, evident by brick movement, cracking, water infiltration, and windows not operating. The condition that caused this damage should be remedied and bricks repaired or replaced. Any underlying damage uncovered should also be repaired or replaced. A qualified contractor is recommended to evaluate and estimate repairs

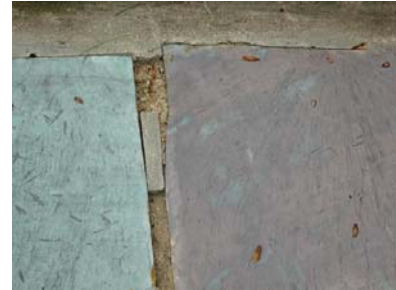
Repair/Replace **Steps/Stoops:** Stone- The stair treads are loose. This is a safety concern that should be addressed promptly.

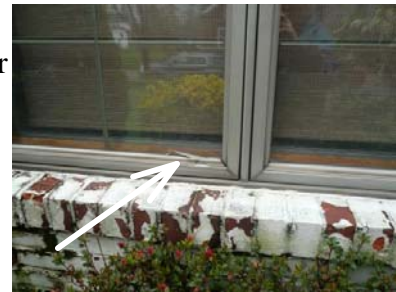
Improve **Windows:** Vinyl casement, Vinyl double hung- The window and door frames require caulking. Any rotted wood uncovered should be repaired or replaced. Damaged frames should be repaired.

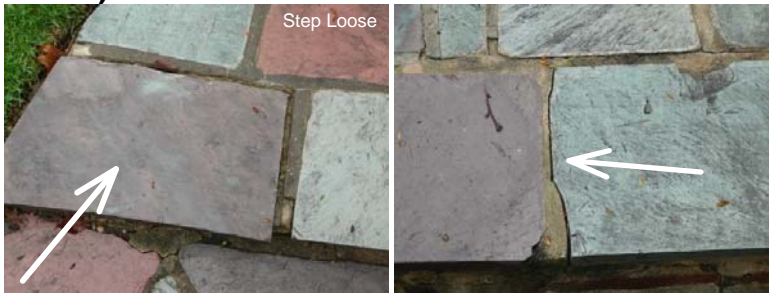
Repair/Replace **Walks:** Stone- The walkway has settled and/or cracked. Persisting movement may result in the need for resurfacing. The walkway presents a trip hazard. This condition should be altered for improved safety.

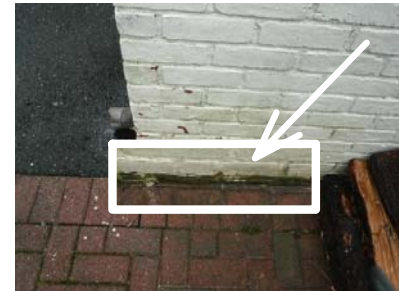
Patio: Brick- The patio should be caulked and sealed adjacent to the foundation.

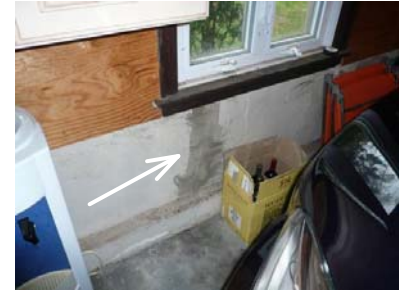
Electrical: 110 VAC GFCI
Walls: Minor cracks were noted.

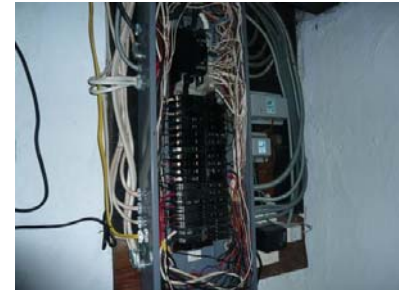
Basement Electric Panel

Improve **Main Panel** 200 Amps- The main distribution panel is crowded with wiring. A larger panel, or an auxiliary panel, would be desirable.

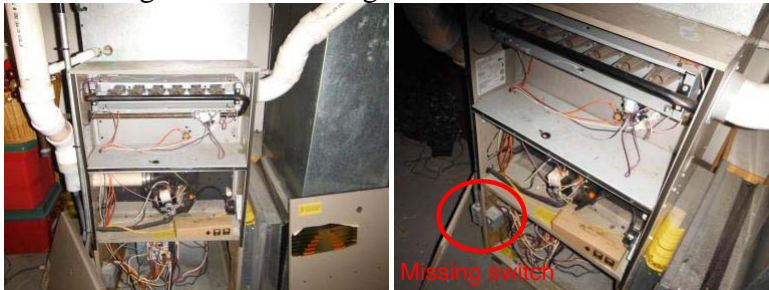
Repair/Replace **Heating System Operation:** The furnace requires typical servicing by a qualified HVAC technician. to clean, service, and check the heat exchanger.

A contact switch should be installed in the lower fan compartment. This will switch will not allow the furnace to operate without the lower cover on. This will help keep the system clean and from overheating the heat exchanger.

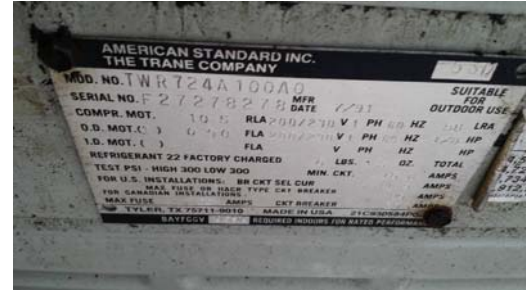
Repair/Replace Heat Pump: Appears serviceable- At the time of inspection the emergency electric heat did not respond to testing. A qualified and licensed air conditioning contractor is recommended to evaluate and estimate repairs.

As is not uncommon for homes of this age and location, the air conditioning system is relatively old. It will require a higher level of maintenance, and may be more prone to major component breakdown. Predicting the frequency or time frame for repairs on any mechanical device is virtually impossible. If the compressor fails, or if breakdowns become chronic, replacing the entire system may be more cost-effective than continuing to undertake repairs. Service recommended.

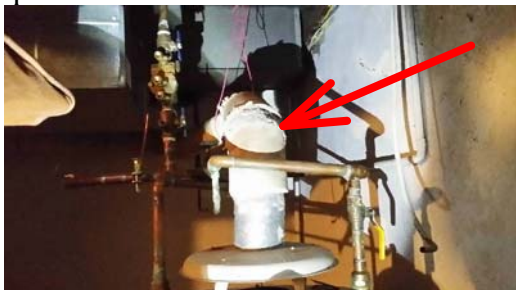
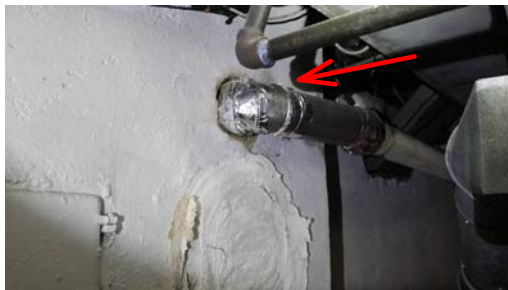
Repair/Replace **Flue Pipe:** Metal. Cast- The flue servicing the water tank is older and may contain asbestos. In addition it does not appear to have a proper slope. It would be wise to remove this flue and upgrade. A qualified licensed HVAC technician should be consulted to evaluate and estimate repair.

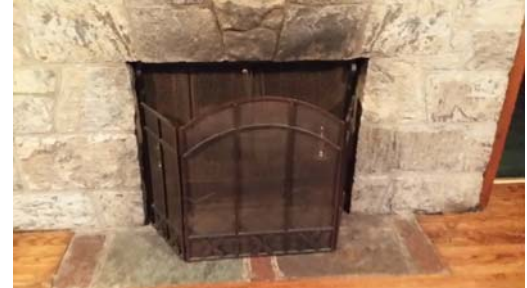
Fireplace Construction: Stone- All the fireplaces and chimneys should have a level two inspections and cleaned prior to operation. A qualified contractor is recommended to evaluate and estimate repairs

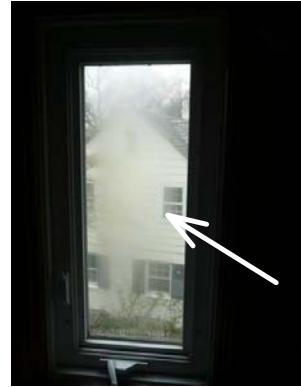
Master Bedroom

Repair/Replace **Windows:** Vinyl casement- A window has lost its seal. This has resulted in condensation developing between the panes of glass. Due to weather conditions or environmental factors, other windows that have lost their seal may exist in the home. A qualified window repair contractor should be engaged to repair all windows as required

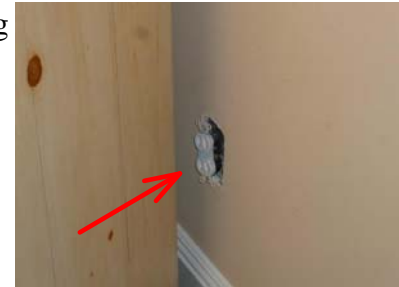
Back Bedroom Bedroom

Improve **Electrical:** 3-Prong- An outlet is loose. It should be improved . Missing cover plate.

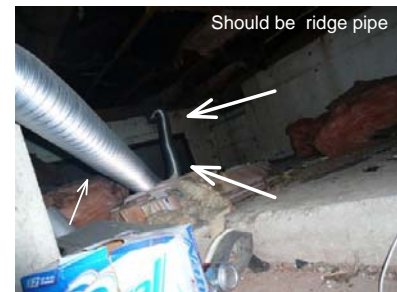
Dryer Vent: Metal flex, Rigid metal- The routing of the dryer vent is less than desirable.

The dryer vent should be made of semi rigid or rigid metal and cleaned prior to use. A partially or fully clogged vent represents a possible fire hazard.

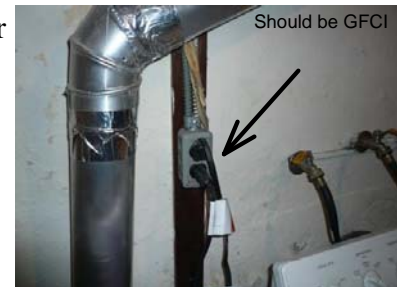
Electrical: 3-Prong- The installation of a ground fault circuit interrupter (GFCI) is recommended. A ground fault circuit interrupter (GFCI) offers protection from shock or electrocution.

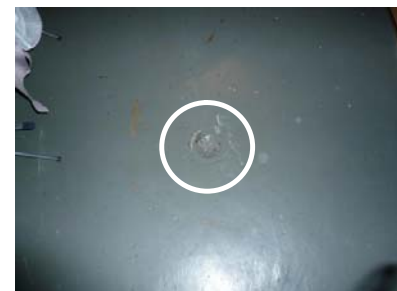
Floor Drain: Surface drain- Blocked by debris
