Property Inspection Report

123 Main Street
Happy Town, NY 11008

Prepared By: Inspecticore Inc License #16000089717

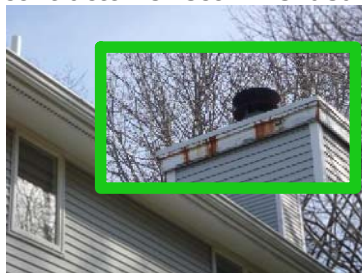
- 2. Chimney Flue/Flue Cap:** Metal - Moisture damage/rot was observed to the chimney cap. A qualified contractor is recommended to evaluate and estimate repairs

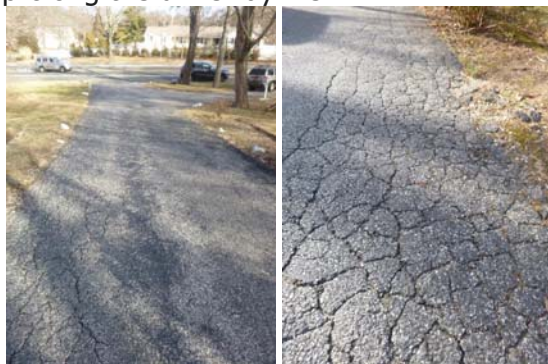
- 3. Driveway:** Asphalt - The driveway surface is weathered. Persistent movement may result in the need for resurfacing. The application of a driveway sealant would offer protection from moisture and sunlight. This may prolong the driveway life.

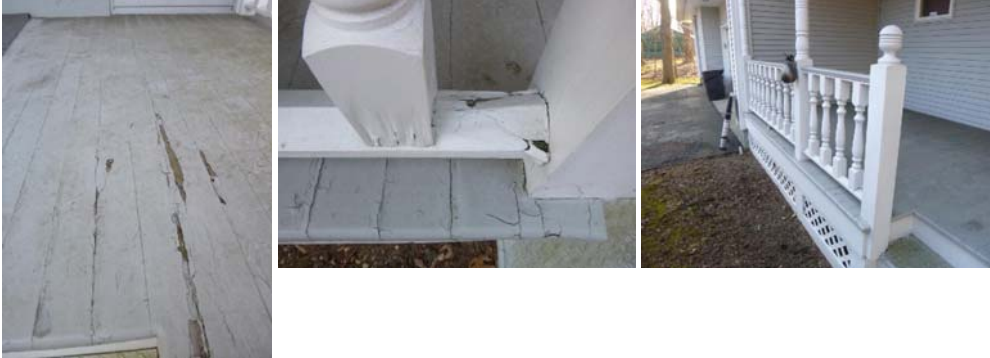
- 4. Porch:** Front Entrance - 1. Moisture damage/rot was observed to the deck surface and railings. Recommend replacing railings and deck boards that show rot.

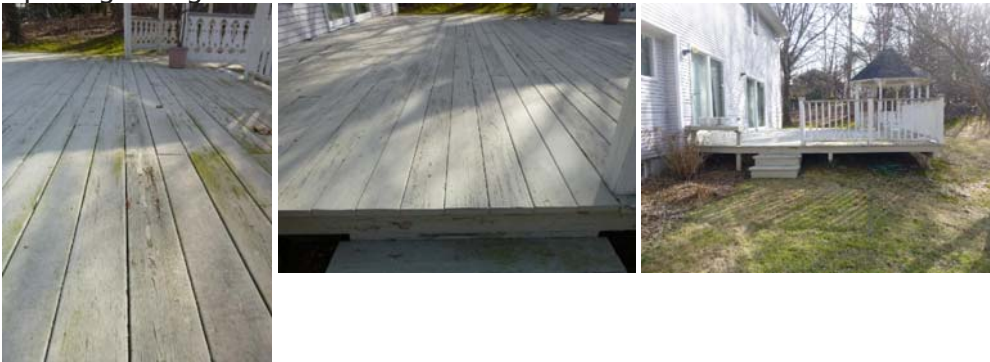
- 5. Deck:** Rear Decks - Moisture damage/rot was observed to the deck surface and railings. Recommend replacing railings and deck boards that show rot.

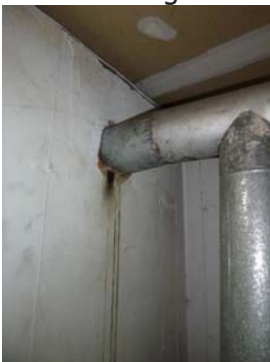
- 6. Heating System Flue Pipe:** Metal - The exhaust system shows evidence that exhaust products have been "back drafting" evident by soot staining. A qualified licensed heating technician should be consulted.

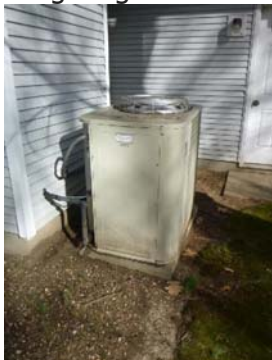
- 7. AC System Exterior Unit:** Pad mounted, Aged - The unit has reached the end of the manufactures stated design life, it may require a slightly higher level of maintenance, and may be more prone to major component breakdown. Predicting the frequency or time frame for repairs on any mechanical device is virtually impossible. Budgeting for new unit is recommended.

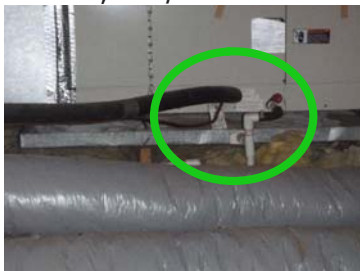
- 8. AC System Condensate Removal:** PVC (Attic) - The condensate line and auxiliary line should not share discharge piping. A second discharge pipe should be run for the air conditioning system to a conspicuous location, and/or a float switch installed in the auxiliary pan.

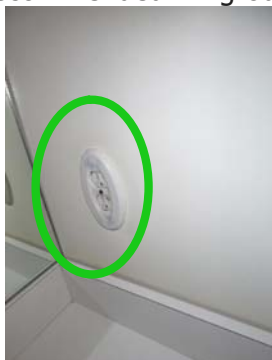
- 9. 2nd Floor Main Bathroom Electrical:** 110 VAC - The installation of a ground fault circuit interrupter (GFCI) is recommended. A ground fault circuit interrupter (GFCI) offers protection from shock or electrocution.
- 10. 2nd Floor Master Bathroom Electrical:** 110 VAC - The installation of a ground fault circuit interrupter (GFCI) is recommended. A ground fault circuit interrupter (GFCI) offers protection from shock or electrocution.
- 11. 1st floor 1/2 bath Bathroom Electrical:** The installation of a ground fault circuit interrupter (GFCI) is recommended. A ground fault circuit interrupter (GFCI) offers protection from shock or electrocution.

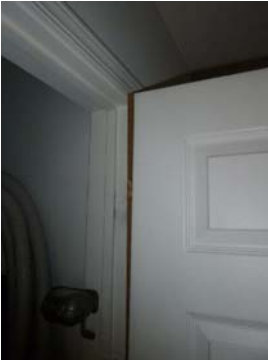
- 12. Entire Home General Finishes Living Space Doors:** Hollow wood - 1. Basement door requires repair/replacement.
2. Doors need trimming/adjustment in various locations

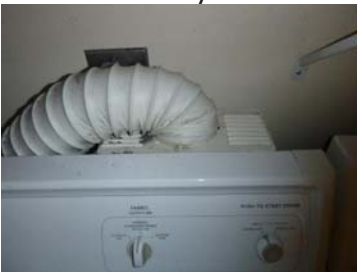
- 13. Laundry Room/Area Dryer Vent:** Plastic flex - 1. The dryer exhaust terminates in the utility closet. excessive lint was observed throughout the utility closet. Dryer vent should terminate at the exterior of the home. Exhaust vents that terminate in the building envelope can lead to unwanted moisture and mold/mildew.
2. The clothes dryer should be vented to the building exterior.

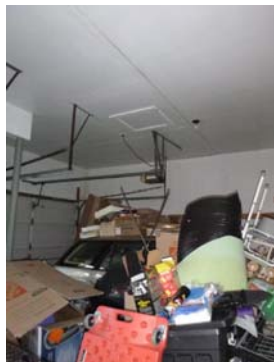
- 1. Over Garage Attic Unable to Inspect:** 100% - Storage or personal items, shelving prevented access to the attic. Recommend inspecting the attic once access is provided.

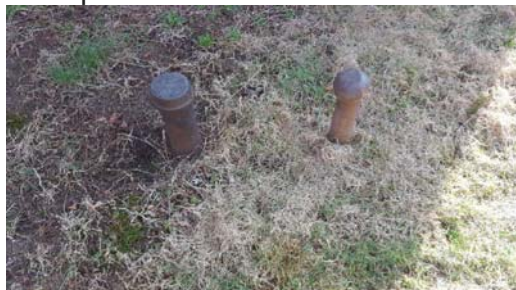
- 2. Buried Oil Tank** An underground oil storage tank exists on the property. According to the Environmental Protection Agency (E.P.A.), this situation may represent an environmental risk depending on factors such as tank age, condition and maintenance, none of which Inspecticore is authorized to investigate or report upon. Possible solutions, subject to state and federal guidelines, may include having the tanks abandoned, filled with sand and/or foam. Oil tank abandonment /removal costs vary depending on the extent of work required. An oil tank specialist should be consulted to evaluate and estimate cost.

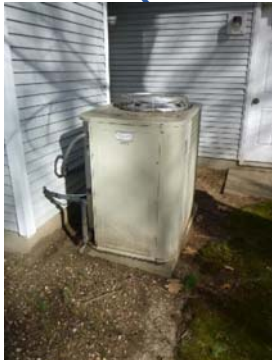
- 3. AC System Operation:** Not inspected - To avoid possible compressor damage due to outside temperature below 60 degrees, the unit was not tested. As is not uncommon for homes of this age and location, the air conditioning system is older. It may require a slightly higher level of maintenance, and may be more prone to major component breakdown. Predicting the frequency or time frame for repairs on any mechanical device is virtually impossible. This unit was manufactured before 2010 indicating it has R22 refrigerant that will be phased out by 2020 as per an EPA ruling.

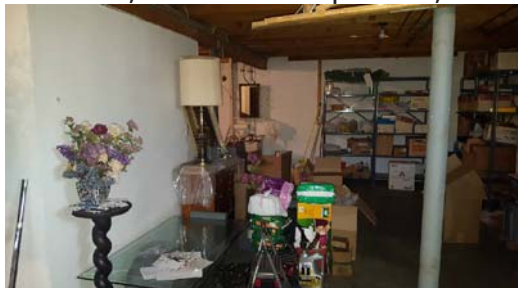
- 1. General Comments:** A licensed general contractor should be consulted to undertake the improvements recommended below.
- 2. Unable to Inspect:** 10% - Storage boxes, Storage shelves, Insulation, Finishes obstructed views of insulation, structural components, electrical, plumbing, HVAC and foundations

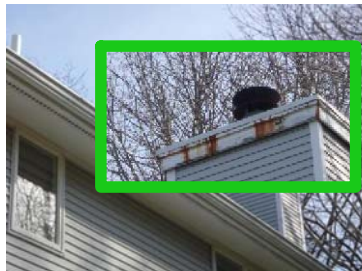
- 14. Repair/Replace** **Flue/Flue Cap:** Metal - Moisture damage/rot was observed to the chimney cap. A qualified contractor is recommended to evaluate and estimate repairs

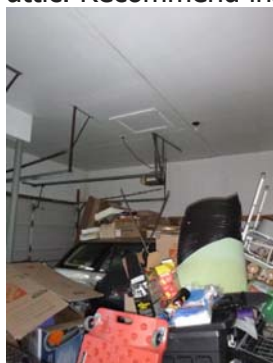
7. Not Inspected **Unable to Inspect:** 100% - Storage or personal items, shelving prevented access to the attic. Recommend inspecting the attic once access is provided.

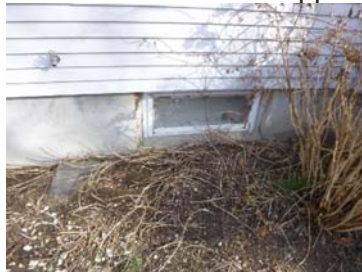
Basement Windows: Vinyl - Routine maintenance is required to the basement windows. New caulk should be applied, any rot to frame should be repaired/replaced.

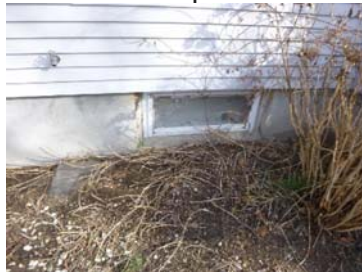
Window Wells: None - Basement window well(s) should be provided when re-grading. Window wells protect basement windows from surface water and prevent contact with the soil.

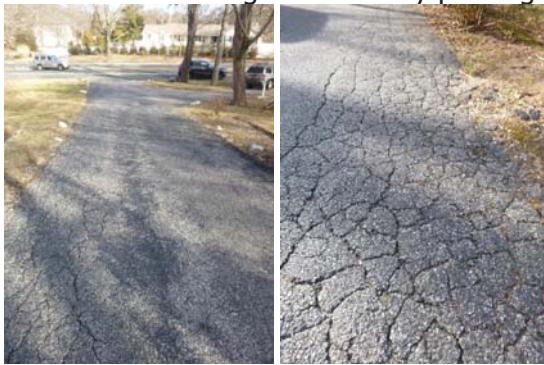
1. Repair/Replace **Driveway:** Asphalt - The driveway surface is weathered. Persistent movement may result in the need for resurfacing. The application of a driveway sealant would offer protection from moisture and sunlight. This may prolong the driveway life.

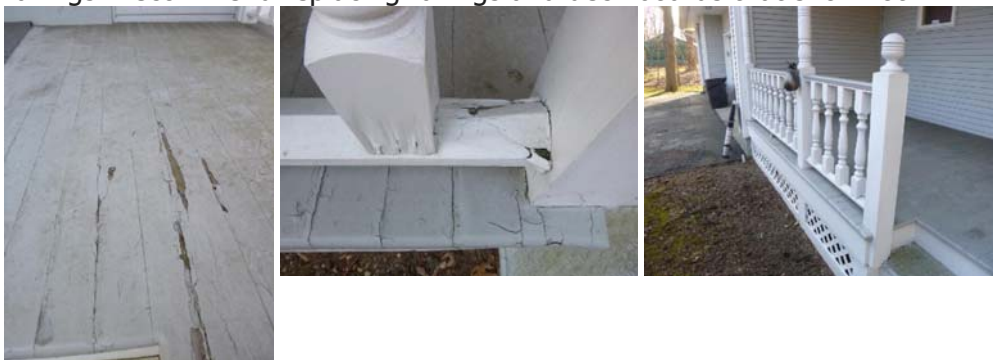
3. Repair/Replace **Porch:** Front Entrance - 1. Moisture damage/rot was observed to the deck surface and railings. Recommend replacing railings and deck boards that show rot.

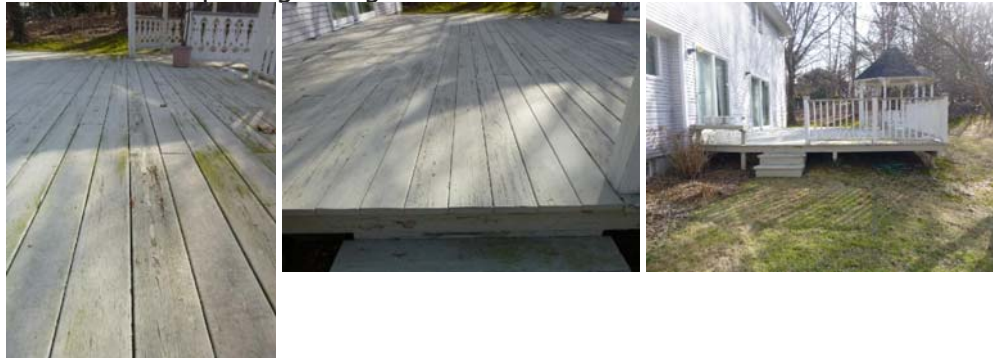
4. Repair/Replace **Deck:** Rear Decks - Moisture damage/rot was observed to the deck surface and railings. Recommend replacing railings and deck boards that show rot.

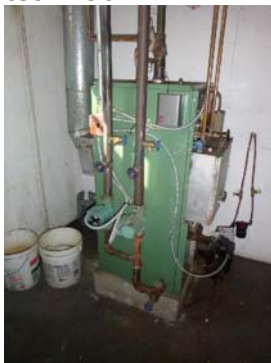
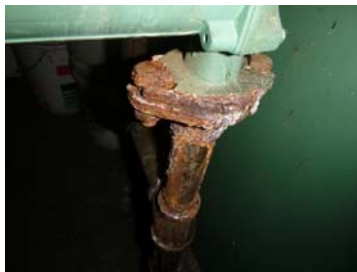
Operation: Aged - Corrosion was noted on various components of the boiler. A qualified and licensed technician should be consulted to repair or replace pipes affected by corrosion, and remedy any leakage issues found. Typical servicing is recommended by a qualified HVAC technician.

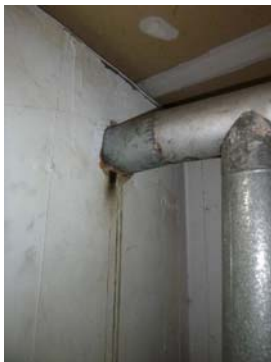
Flue Pipe: Metal - The exhaust system shows evidence that exhaust products have been "back drafting" evident by soot staining. A qualified licensed heating technician should be consulted.

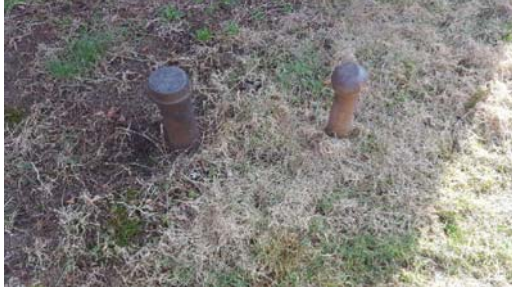
- 9. Not Inspected Buried Oil Tank** An underground oil storage tank exists on the property. According to the Environmental Protection Agency (E.P.A.), this situation may represent an environmental risk depending on factors such as tank age, condition and maintenance, none of which Inspecticore is authorized to investigate or report upon. Possible solutions, subject to state and federal guidelines, may include having the tanks abandoned, filled with sand and/or foam. Oil tank abandonment /removal costs vary depending on the extent of work required. An oil tank specialist should be consulted to evaluate and estimate cost.

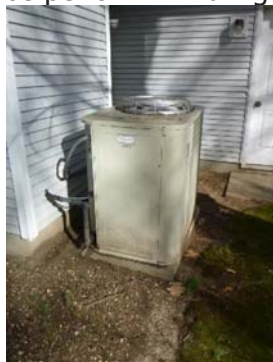
5. Not Inspected Operation: Not inspected - To avoid possible compressor damage due to outside temperature below 60 degrees, the unit was not tested. As is not uncommon for homes of this age and location, the air conditioning system is older. It may require a slightly higher level of maintenance, and may be more prone to major component breakdown. Predicting the frequency or time frame for repairs on any mechanical device is virtually impossible. This unit was manufactured before 2010 indicating it has R22 refrigerant that will be phased out by 2020 as per an EPA ruling.

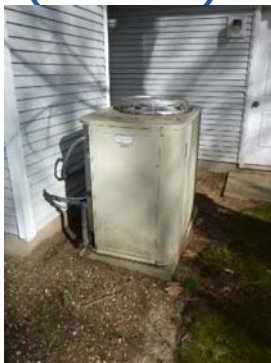
6. Repair/Replace Exterior Unit: Pad mounted, Aged - The unit has reached the end of the manufactures stated design life, it may require a slightly higher level of maintenance, and may be more prone to major component breakdown. Predicting the frequency or time frame for repairs on any mechanical device is virtually impossible. Budgeting for new unit is recommended.

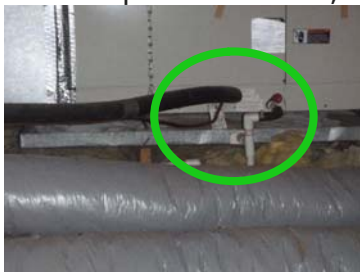
- 7. **Electrical Disconnect:** Disconnect
- 8. **Refrigerant Lines:** Serviceable condition
- 9. Repair/Replace **Condensate Removal:** PVC (Attic) - The condensate line and auxiliary line should not share discharge piping. A second discharge pipe should be run for the air conditioning system to a conspicuous location, and/or a float switch installed in the auxiliary pan.

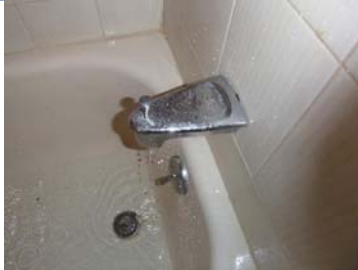
Faucets/Traps: Shower body (Shower faucet) - The shower body (shower faucet) is loose in the wall. Evaluate and repair.

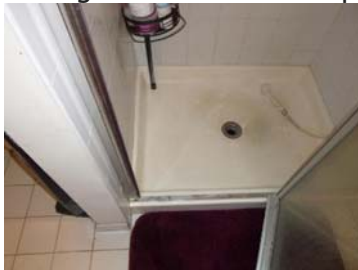
**10.** Repair/Replace**Electrical:** 110 VAC - The installation of a ground fault circuit interrupter (GFCI) is recommended. A ground fault circuit interrupter (GFCI) offers protection from shock or electrocution.**11.** Acceptable**Ventilation:** Window**12.** Acceptable**HVAC Source:** Baseboard**13.** Improve**Shower/Surround:** Fiberglass pan and ceramic tile surround - The shower pan needs cleaning. Routine maintenance is required. Caulking and grout should be renewed. Any damaged tile should be repaired/replaced.

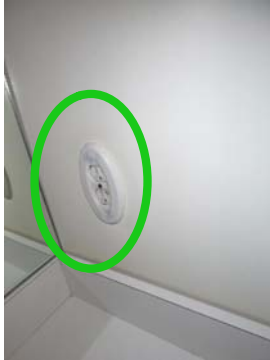
- 17.** Repair/Replace **Electrical:** The installation of a ground fault circuit interrupter (GFCI) is recommended. A ground fault circuit interrupter (GFCI) offers protection from shock or electrocution.

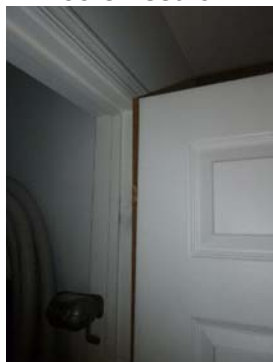
2. Improve **Walls:** Drywall - Typical drywall flaws were observed various locations, Minor cracks were noted in various locations
3. Improve **Ceiling:** Drywall - Typical drywall flaws were observed various locations, Minor cracks were noted in various locations
4. Improve **Floor:** Hardwood, Carpet, Tile - Floor slopes are apparent in various locations
5. Improve **Windows:** Vinyl, Wood - Windows need trimming/adjustment in various locations.
6. Repair/Replace **Doors:** Hollow wood -
 1. Basement door requires repair/replacement.
 2. Doors need trimming/adjustment in various locations

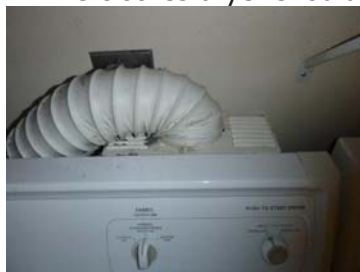
5. Repair/Replace Dryer Vent: Plastic flex - 1. The dryer exhaust terminates in the utility closet. excessive lint was observed throughout the utility closet. Dryer vent should terminate at the exterior of the home. Exhaust vents that terminate in the building envelope can lead to unwanted moisture and mold/mildew.

2. The clothes dryer should be vented to the building exterior.

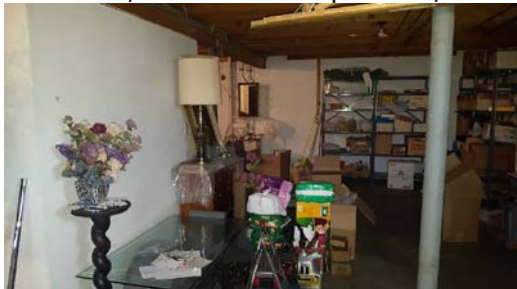
- 1. Unable to Inspect:** 10% - Storage boxes, Storage shelves, Insulation, Finishes obstructed views of insulation, structural components, electrical, plumbing, HVAC and foundations
