Property Inspection Report

123 Main Street
Happy Town, NY 11008

Prepared By: Blaise Ingrisano License #16000035230

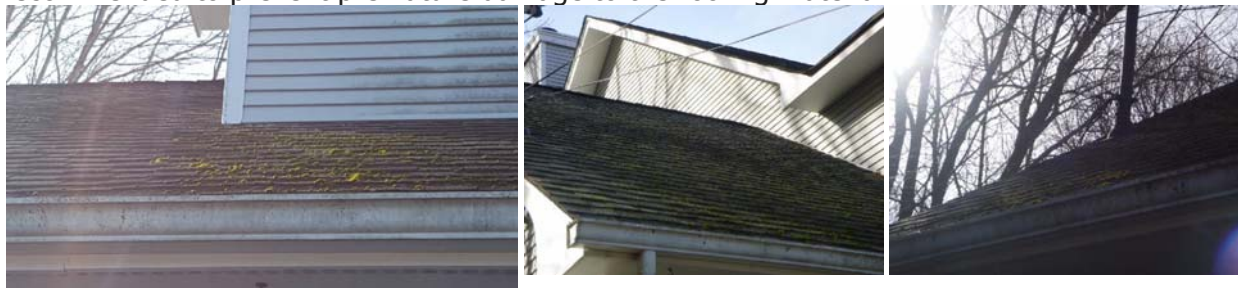
- 1. Roof Surface Material:** Asphalt composite shingle - The roofing shows evidence of significant moss and organic build up. This condition may influence the life expectancy of the roofing. Moss removal is recommended to prevent premature damage to the roofing material.

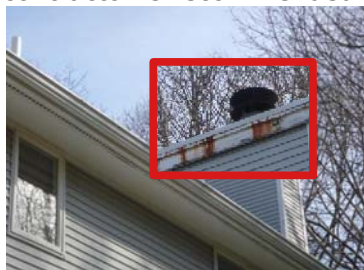
- 2. Chimney Flue/Flue Cap:** Metal - Moisture damage/rot was observed to the chimney cap. A qualified contractor is recommended to evaluate and estimate repairs

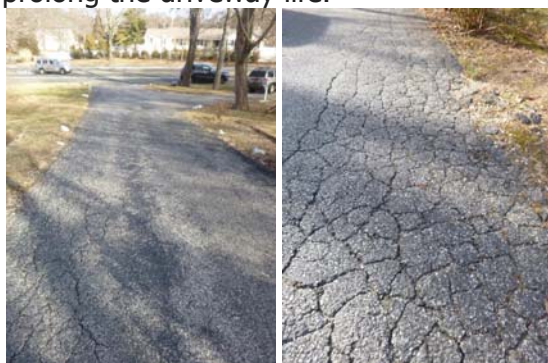
- 3. Driveway:** Asphalt - The driveway surface is weathered. Persistent movement may result in the need for resurfacing. The application of a driveway sealant would offer protection from moisture and sunlight. This may prolong the driveway life.

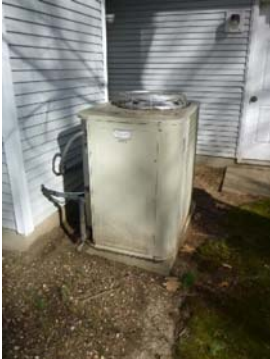
- 7. AC System Exterior Unit:** Pad mounted, Aged - The unit has reached the end of the manufactures stated design life, it may require a slightly higher level of maintenance, and may be more prone to major component breakdown. Predicting the frequency or time frame for repairs on any mechanical device is virtually impossible. Budgeting for new unit is recommended.

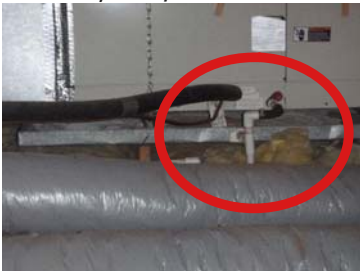
- 8. AC System Condensate Removal:** PVC (Attic) - The condensate line and auxiliary line should not share discharge piping. A second discharge pipe should be run for the air conditioning system to a conspicuous location, and/or a float switch installed in the auxiliary pan.

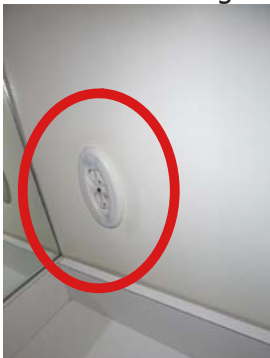
- 9. 2nd Floor Main Bathroom Electrical:** 110 VAC - The installation of a ground fault circuit interrupter (GFCI) is recommended. A ground fault circuit interrupter (GFCI) offers protection from shock or electrocution.
- 10. 2nd Floor Master Bathroom Electrical:** 110 VAC - The installation of a ground fault circuit interrupter (GFCI) is recommended. A ground fault circuit interrupter (GFCI) offers protection from shock or electrocution.
- 11. 1st floor 1/2 bath Bathroom Electrical:** The installation of a ground fault circuit interrupter (GFCI) is recommended. A ground fault circuit interrupter (GFCI) offers protection from shock or electrocution.

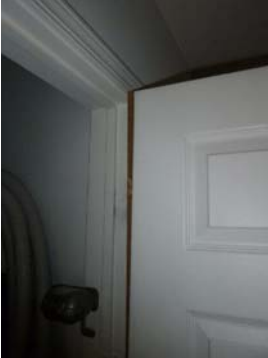
- 12. Entire Home General Finishes Living Space Doors:** Hollow wood - 1. Basement door requires repair/replacement.
2. Doors need trimming/adjustment in various locations

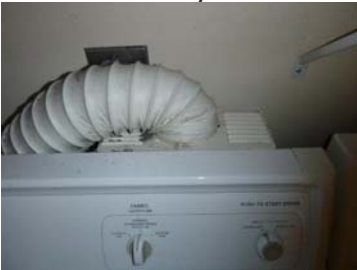
- 13. Laundry Room/Area Dryer Vent:** Plastic flex - 1. The dryer exhaust terminates in the utility closet. excessive lint was observed throughout the utility closet. Dryer vent should terminate at the exterior of the home. Exhaust vents that terminate in the building envelope can lead to unwanted moisture and mold/mildew.
2. The clothes dryer should be vented to the building exterior.

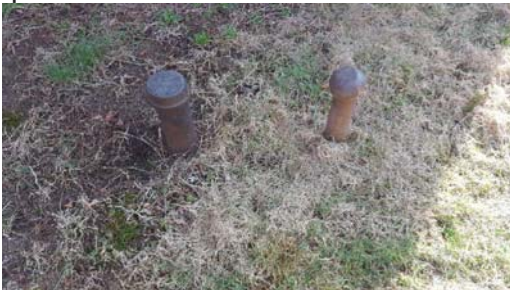
- 2. Buried Oil Tank** An underground oil storage tank exists on the property. According to the Environmental Protection Agency (E.P.A.), this situation may represent an environmental risk depending on factors such as tank age, condition and maintenance, none of which A-Pro is authorized to investigate or report upon. Possible solutions, subject to state and federal guidelines, may include having the tanks abandoned, filled with sand and/or foam. Oil tank abandonment /removal costs vary depending on the extent of work required. An oil tank specialist should be consulted to evaluate and estimate cost.

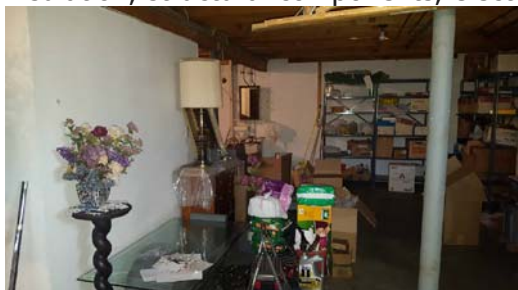
- 1. General Comments:** A licensed general contractor should be consulted to undertake the improvements recommended below.
- 2. Unable to Inspect:** 10% - Storage boxes, Storage shelves, Insulation, Finishes obstructed views of insulation, structural components, electrical, plumbing, HVAC and foundations

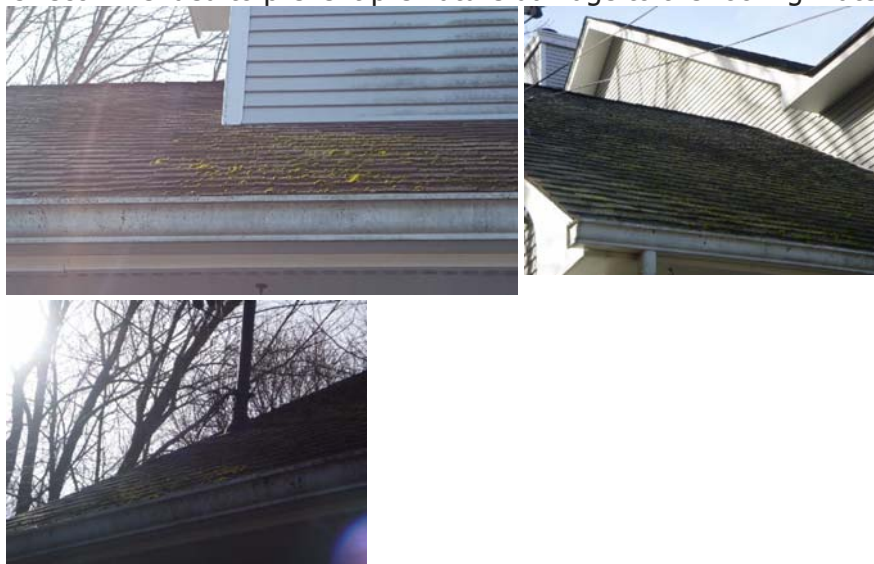
5. Repair/Replace Material: Asphalt composite shingle - The roofing shows evidence of significant moss and organic build up. This condition may influence the life expectancy of the roofing. Moss removal is recommended to prevent premature damage to the roofing material.

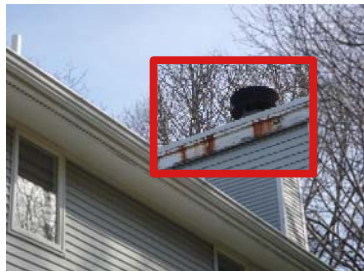
14. Repair/Replace **Flue/Flue Cap:** Metal - Moisture damage/rot was observed to the chimney cap. A qualified contractor is recommended to evaluate and estimate repairs

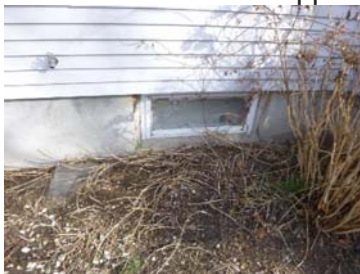
Basement Windows: Vinyl - Routine maintenance is required to the basement windows. New caulk should be applied, any rot to frame should be repaired/replaced.

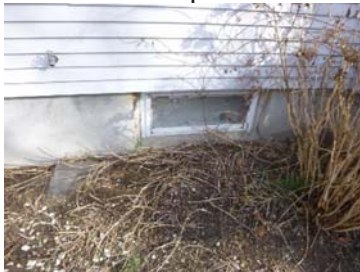
Window Wells: None - Basement window well(s) should be provided when re-grading. Window wells protect basement windows from surface water and prevent contact with the soil.

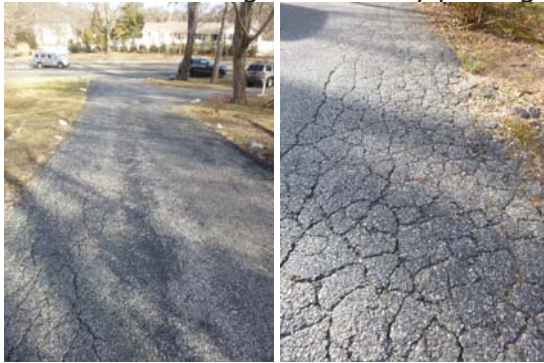
- 1. Repair/Replace Driveway:** Asphalt - The driveway surface is weathered. Persistent movement may result in the need for resurfacing. The application of a driveway sealant would offer protection from moisture and sunlight. This may prolong the driveway life.

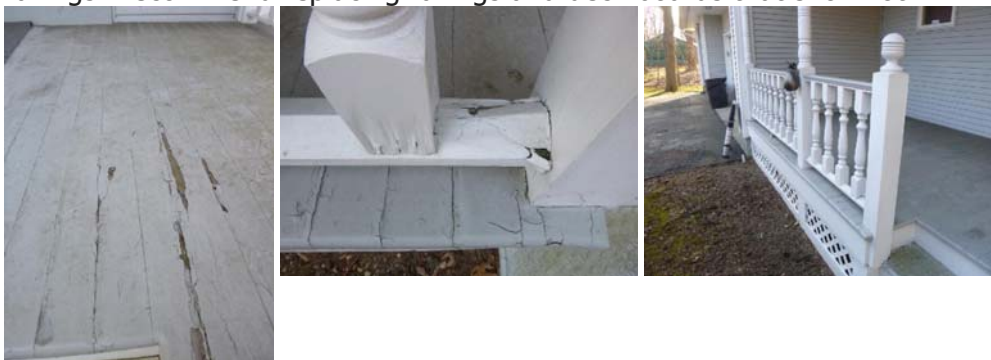
- 3. Repair/Replace Porch:** Front Entrance - 1. Moisture damage/rot was observed to the deck surface and railings. Recommend replacing railings and deck boards that show rot.

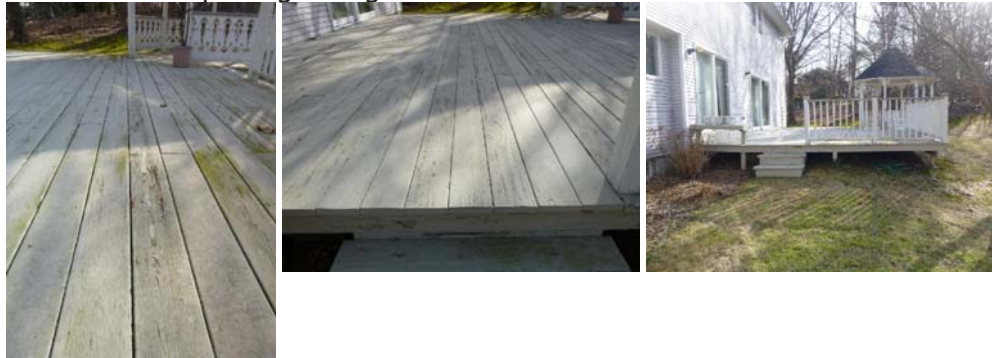
4. Repair/Replace **Deck:** Rear Decks - Moisture damage/rot was observed to the deck surface and railings. Recommend replacing railings and deck boards that show rot.

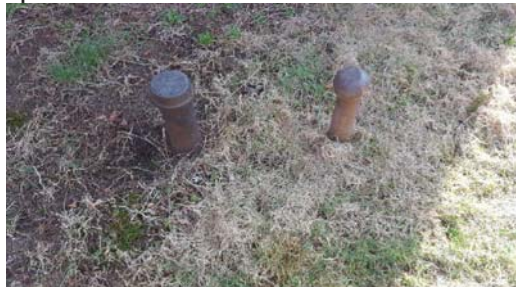
- 9. Not Inspected Buried Oil Tank** An underground oil storage tank exists on the property. According to the Environmental Protection Agency (E.P.A.), this situation may represent an environmental risk depending on factors such as tank age, condition and maintenance, none of which A-Pro is authorized to investigate or report upon. Possible solutions, subject to state and federal guidelines, may include having the tanks abandoned, filled with sand and/or foam. Oil tank abandonment /removal costs vary depending on the extent of work required. An oil tank specialist should be consulted to evaluate and estimate cost.

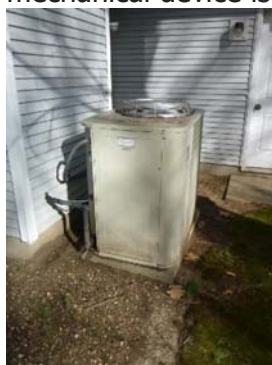
6. Repair/Replace Exterior Unit: Pad mounted, Aged - The unit has reached the end of the manufactures stated design life, it may require a slightly higher level of maintenance, and may be more prone to major component breakdown. Predicting the frequency or time frame for repairs on any mechanical device is virtually impossible. Budgeting for new unit is recommended.

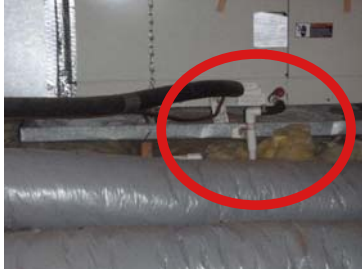
- 9. Repair/Replace Condensate Removal:** PVC (Attic) - The condensate line and auxiliary line should not share discharge piping. A second discharge pipe should be run for the air conditioning system to a conspicuous location, and/or a float switch installed in the auxiliary pan.

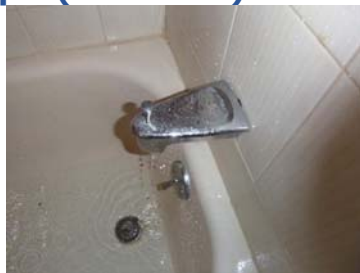
Faucets/Traps: Shower body (Shower faucet) - The shower body (shower faucet) is loose in the wall. Evaluate and repair.

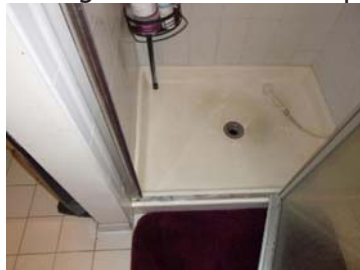
**10.** Repair/Replace**Electrical:** 110 VAC - The installation of a ground fault circuit interrupter (GFCI) is recommended. A ground fault circuit interrupter (GFCI) offers protection from shock or electrocution.**11.** Acceptable**Ventilation:** Window**12.** Acceptable**HVAC Source:** Baseboard**13.** Improve**Shower/Surround:** Fiberglass pan and ceramic tile surround - The shower pan needs cleaning. Routine maintenance is required. Caulking and grout should be renewed. Any damaged tile should be repaired/replaced.

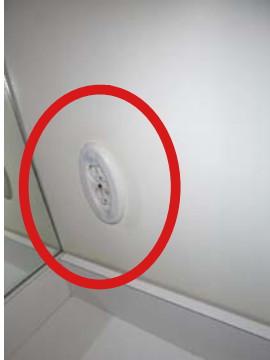
- 17.** Repair/Replace **Electrical:** The installation of a ground fault circuit interrupter (GFCI) is recommended. A ground fault circuit interrupter (GFCI) offers protection from shock or electrocution.

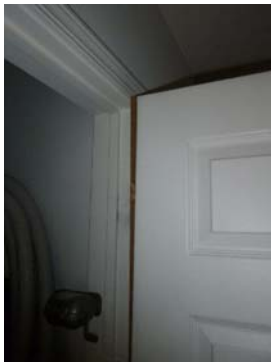
2. Improve **Walls:** Drywall - Typical drywall flaws were observed various locations, Minor cracks were noted in various locations
3. Improve **Ceiling:** Drywall - Typical drywall flaws were observed various locations, Minor cracks were noted in various locations
4. Improve **Floor:** Hardwood, Carpet, Tile - Floor slopes are apparent in various locations
5. Improve **Windows:** Vinyl, Wood - Windows need trimming/adjustment in various locations.
6. Repair/Replace **Doors:** Hollow wood - 1. Basement door requires repair/replacement.
2. Doors need trimming/adjustment in various locations

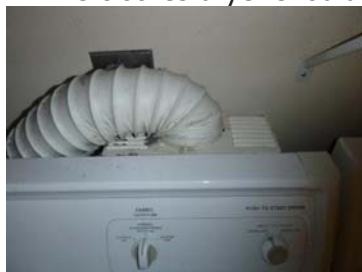
5. Repair/Replace Dryer Vent: Plastic flex - 1. The dryer exhaust terminates in the utility closet. excessive lint was observed throughout the utility closet. Dryer vent should terminate at the exterior of the home. Exhaust vents that terminate in the building envelope can lead to unwanted moisture and mold/mildew.

2. The clothes dryer should be vented to the building exterior.
