A-PRO HOME INSPECTIONS
8 SAGGESE LANE
NESCONSET, NY 11767
PREPARED BY:BLAISE INGRISANO
NYS Lic#16000035230

123 Main Street
Happy Town, NY 10000

Repair/Replace Summary

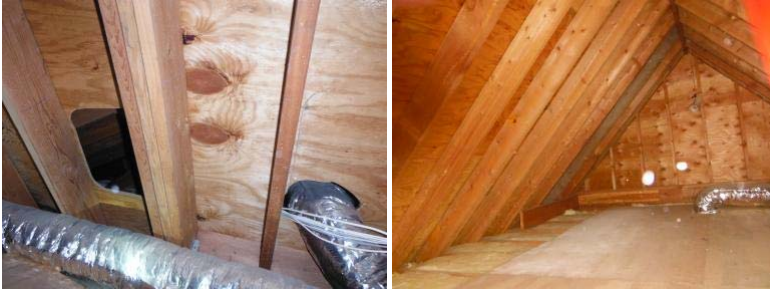
Method of Inspection: Viewed From Hatch, Entered-Inaccessible Areas

Unable to Inspect: 65%- Finishes obstructed views of insulation, structural components, electrical, plumbing, HVAC components, Safety and footing, Roof line
