Property Inspection Report

123 Main Street
Happy Town, NY 11008

Prepared By: Inspecticore Inc License #16000089717

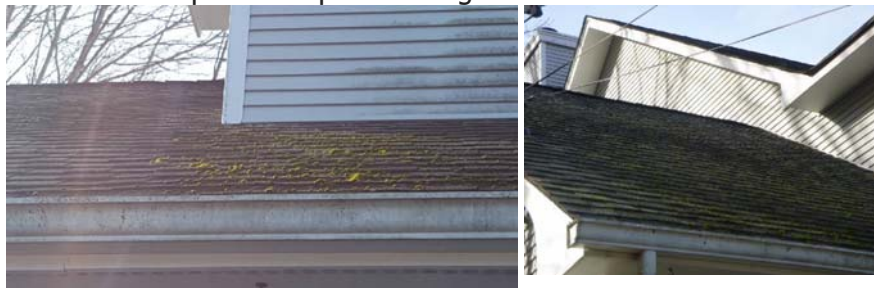
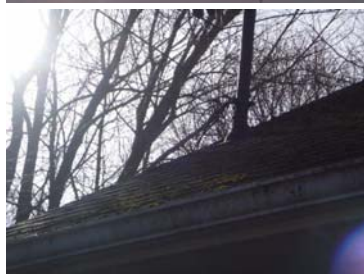
5. Repair/Replace Material: Asphalt composite shingle

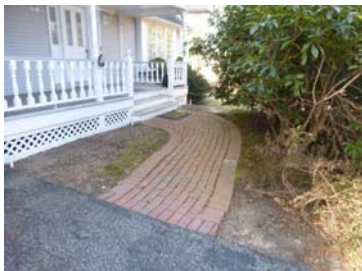
3. Repair/Replace **Porch:** Front Entrance - 1. Moisture damage/rot was observed to the deck surface and railings. Recommend replacing railings and deck boards that show rot.

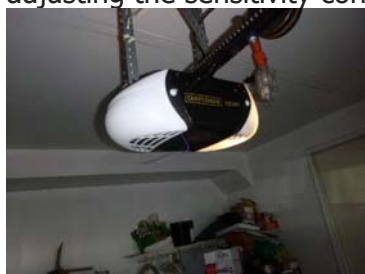
1. **Type of Structure:** Attached **Car Spaces:** 3
2. Acceptable **Garage Doors:** Insulated aluminum
3. Acceptable **Door Operation:** Mechanized
4. Improve **Door Opener:** Craftsman - Although the garage door opener photo sensor did function properly, the door did not automatically reverse under resistance to closing. There is a serious risk of injury, particularly to children, under this condition. Improvement may be as simple as adjusting the sensitivity control on the opener.

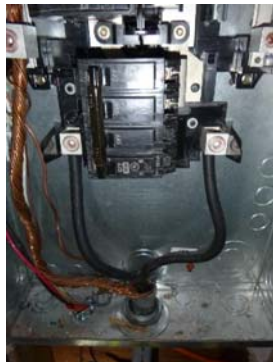
4. Acceptable **Main Panel** 200 Amps - The main distribution panel is a Federal Pacific electric brand service panel. These panels are considered to be a latent safety hazard by many licensed electricians. The Consumer Product Safety Commission did a study in the 1980s regarding circuit breakers that fail to trip under certain overload conditions. For this reason, the panel should be examined by a licensed electrician familiar with the CPSC study to determine its continued safety and to recommend upgrade options if necessary.

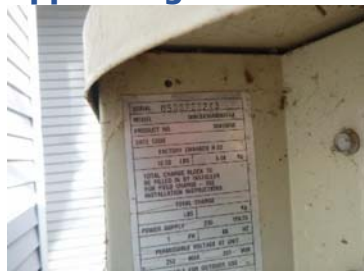
5. Not Inspected Operation: Not inspected - To avoid possible compressor damage due to outside temperature below 60 degrees, the unit was not tested. As is not uncommon for homes of this age and location, the air conditioning system is older. It may require a slightly higher level of maintenance, and may be more prone to major component breakdown. Predicting the frequency or time frame for repairs on any mechanical device is virtually impossible. This unit was manufactured before 2010 indicating it has R22 refrigerant that will be phased out by 2020 as per an EPA ruling.

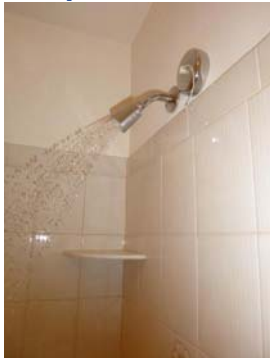
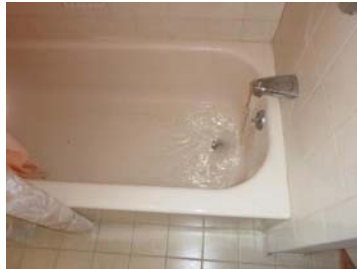
Faucets/Traps: Shower body (Shower faucet) - The shower body (shower faucet) is loose in the wall. Evaluate and repair.

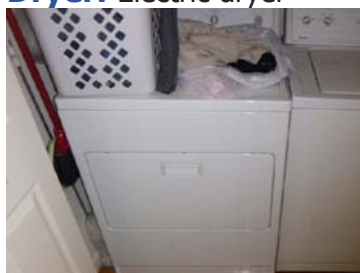
5. Repair/Replace Dryer Vent: Plastic flex - 1. The dryer exhaust terminates in the utility closet. excessive lint was observed throughout the utility closet. Dryer vent should terminate at the exterior of the home. Exhaust vents that terminate in the building envelope can lead to unwanted moisture and mold/mildew.

2. The clothes dryer should be vented to the building exterior.
