Property Inspection Report

123 Main Street
Happy Town, NY 11008

Prepared By: Blaise Ingrisano License #16000035230

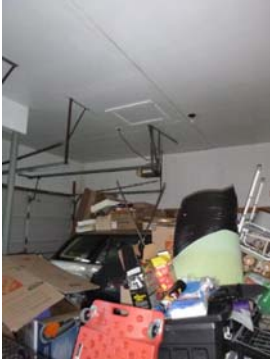
- 1. Over Garage Attic Unable to Inspect:** 100% - Storage or personal items, shelving prevented access to the attic. Recommend inspecting the attic once access is provided.

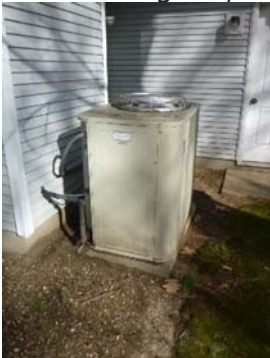
- 3. AC System Operation:** Not inspected - To avoid possible compressor damage due to outside temperature below 60 degrees, the unit was not tested.

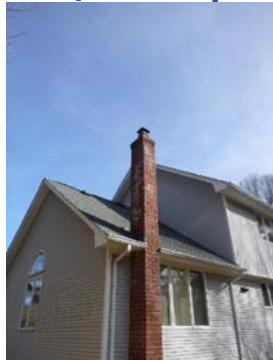
14. Repair/Replace **Flue/Flue Cap:** Metal - Moisture damage/rot was observed to the chimney cap. A qualified contractor is recommended to evaluate and estimate repairs

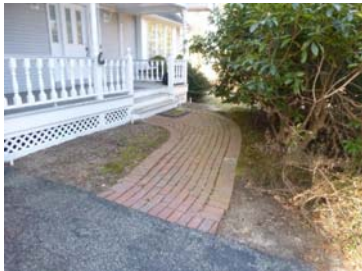
- 3. Repair/Replace Porch:** Front Entrance - 1. Moisture damage/rot was observed to the deck surface and railings. Recommend replacing railings and deck boards that show rot.

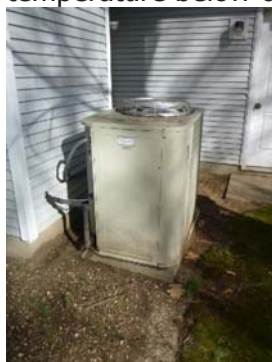
6. Repair/Replace Exterior Unit: Pad mounted, Aged - The unit has reached the end of the manufactures stated design life, it may require a slightly higher level of maintenance, and may be more prone to major component breakdown. Predicting the frequency or time frame for repairs on any mechanical device is virtually impossible. Budgeting for new unit is recommended.

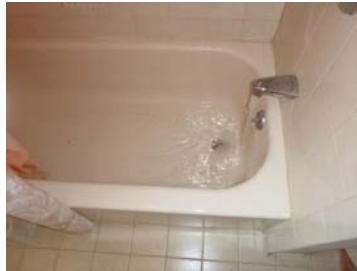
Faucets/Traps: Shower body (Shower faucet) - The shower body (shower faucet) is loose in the wall. Evaluate and repair.

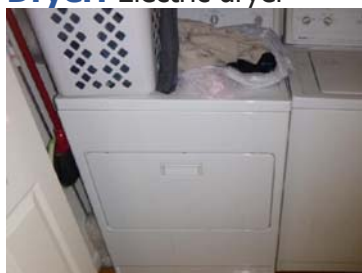
5. Repair/Replace Dryer Vent: Plastic flex - 1. The dryer exhaust terminates in the utility closet. excessive lint was observed throughout the utility closet. Dryer vent should terminate at the exterior of the home. Exhaust vents that terminate in the building envelope can lead to unwanted moisture and mold/mildew.

2. The clothes dryer should be vented to the building exterior.

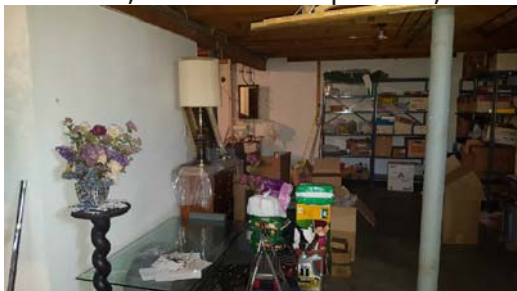
- 1. Unable to Inspect:** 10% - Storage boxes, Storage shelves, Insulation, Finishes obstructed views of insulation, structural components, electrical, plumbing, HVAC and foundations
